This errata sheet provides updated information on known device issues affecting Cyclone® IV devices.

Table 1. Known Issues for Cyclone IV Devices (Part 1 of 2)

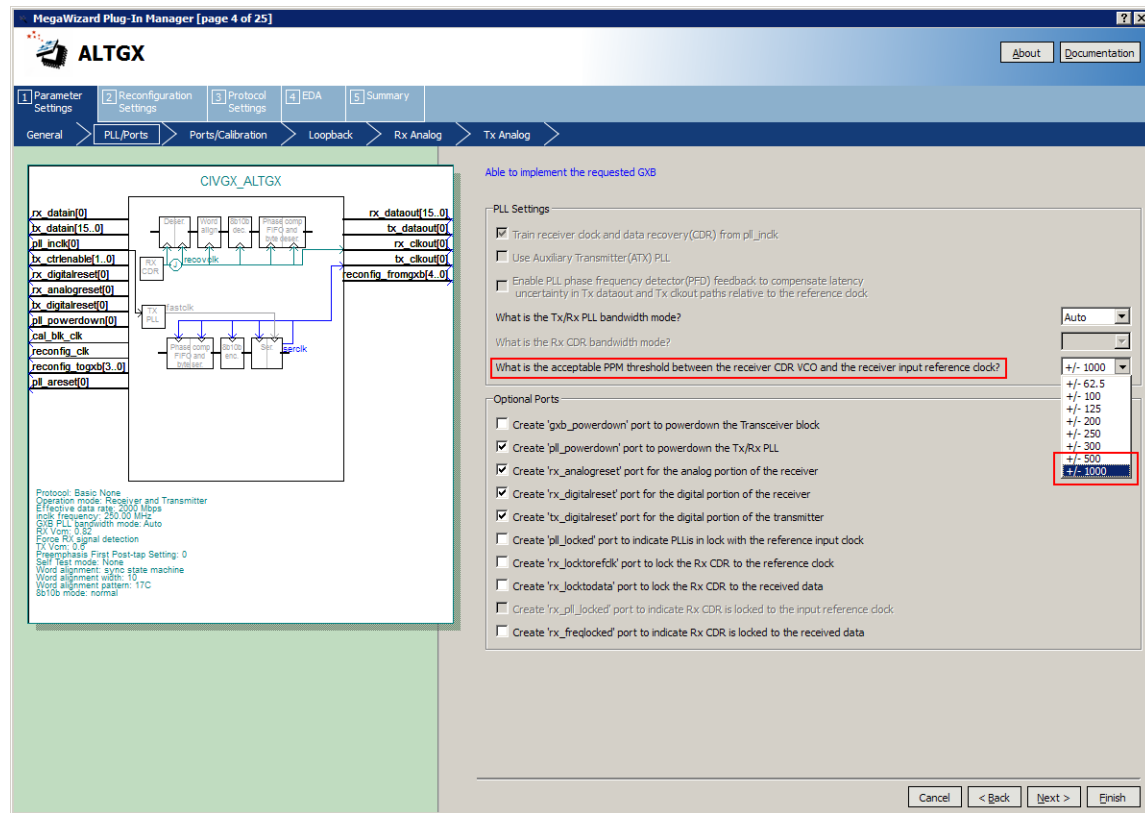
Figure 1. Programmable PPM Detector Options in the ALTGX MegaWizard Plug-In Manager

The ±500 PPM and ±1000 PPM options for the Programmable PPM Detector feature in the ALTGX MegaWizard™ Plug-In Manager, as shown in [Figure 1](#), are no longer supported in the Quartus II software version 10.0 SP1 and later. These options are removed because the programmed PPM threshold values exceed the receiver CDR PPM tolerance between the upstream transmitter reference clock and the local receiver reference clock.

Designs compiled with the Quartus II software version 10.0 and earlier may have a link failure risk when the receiver is operating in a system that has ± 500 PPM or ± 1000 PPM differences for the reference clock frequencies between the upstream transmitter and the local receiver. Using CDR Manual Lock mode does not overcome the link failure risk.

For a receiver design that has the ± 500 PPM or ± 1000 PPM options selected in the Programmable PPM Detector feature, Altera recommends evaluating the system operation with different options, ranging between ± 62.5 PPM and ± 300 PPM. To change the **Programmable PPM Detector** option, regenerate and recompile the ALTGX MegaWizard Plug-In Manager design file with the supported options.
